Policeman's Cottage - Reservoir Road, Prospect

Fabric Analysis & Schedule of Conservation Works

October 2013

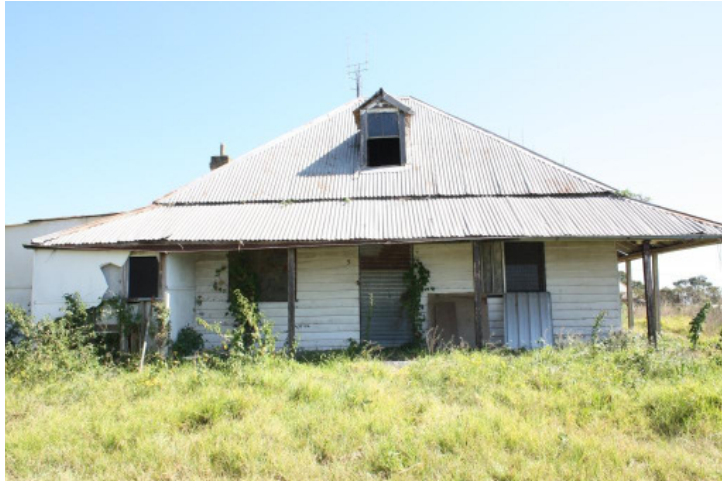
Figure 1: Eastern elevation.

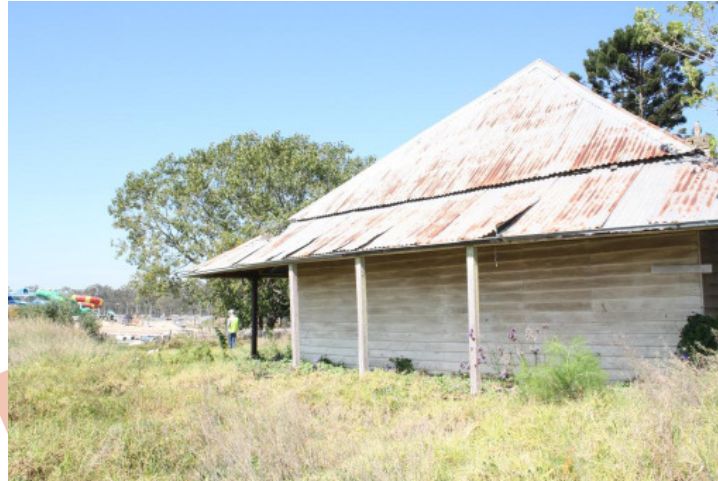
Figure 2: Northern elevation.

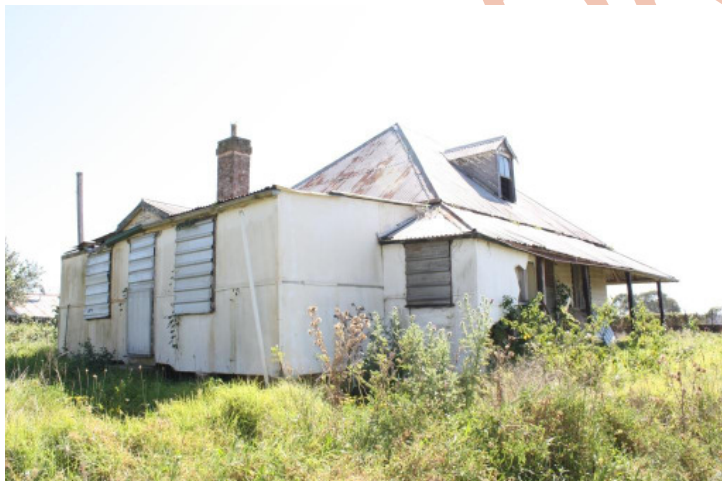
Figure 3: South eastern corner.

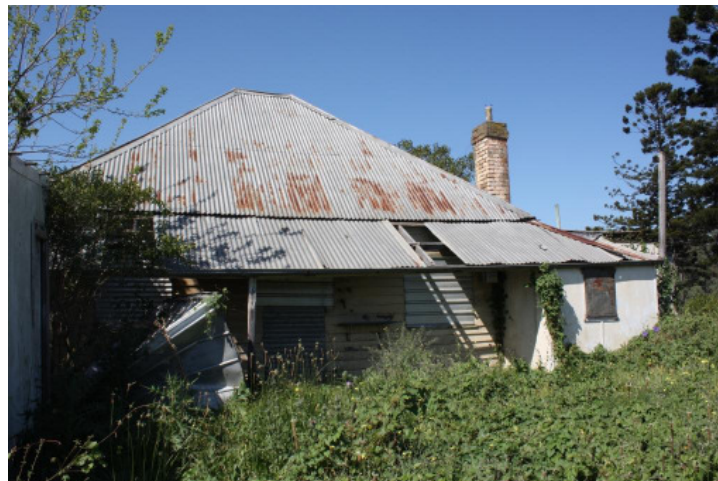
Figure 4: Western elevation.

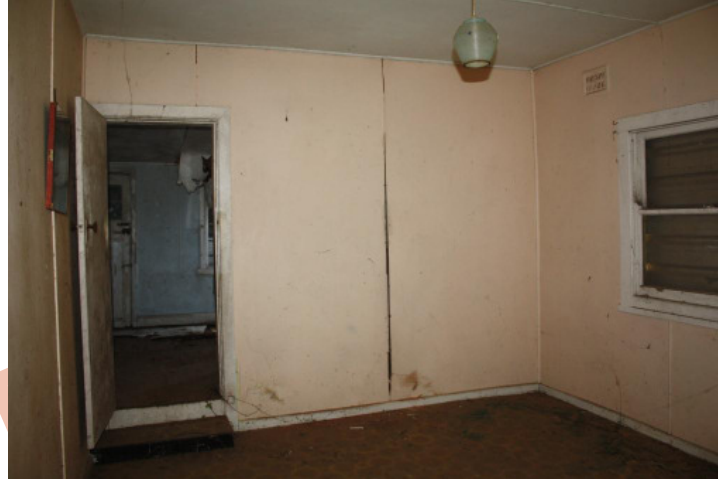
Figure 10: Space 5 - Fibre cement sheeting cladding the walls of Space 5.

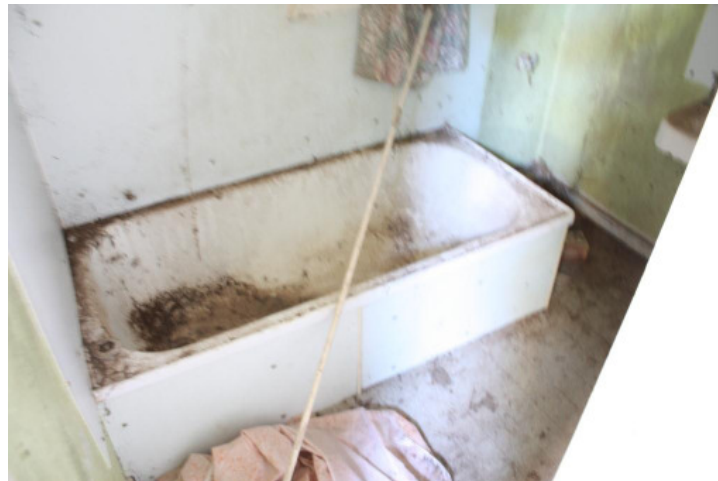
Figure 12: Space 8 - Bathroom 2.

Bathroom fittings and fixtures	Bath, vanity with basin (dilapidated), wall cupboard with mirror front. Toilet and all tapware missing.	Poor	<ul style="list-style-type: none"> Make safe. To make this bathroom usable it will require a full refurbishment.

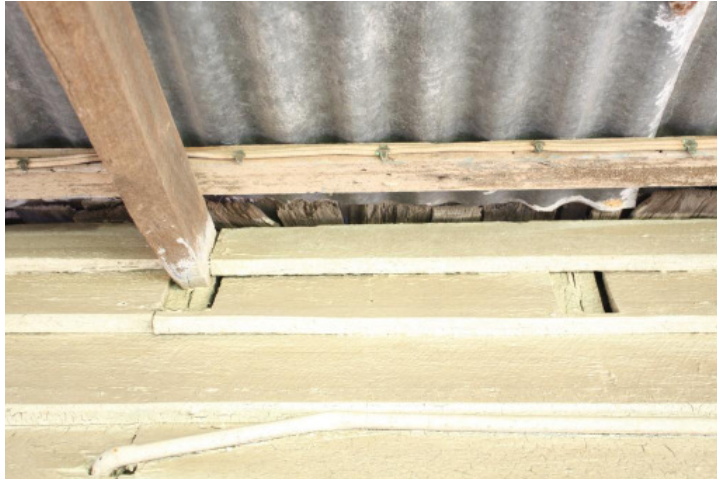
Figure 13: Detail showing exposed edge of earlier timber shingle roof.

Dormer window - W1	Framed in hand hewn members, external timber weatherboards (set on the diagonal), corrugated iron roofing (no shingles evident, however batten spaces indicates earlier shingle roof has been removed), timber casement window sash framing (glass missing).	Fair/poor	<ul style="list-style-type: none"> This window is currently open to the elements. As a matter of urgency, the window should be repaired or carefully boarded up to prevent further deterioration or loss of fabric. The dormer structure should be inspected to check for insect infestation. Allow to repair dormer roof flashings to ensure weather protection to the roof space. Repair weathered timber cladding, including any missing trims and flashings. Replacement trims and flashings are to match the existing in terms of material, hardness, dimension and profile. Allow to install new glazing to the dormer window.

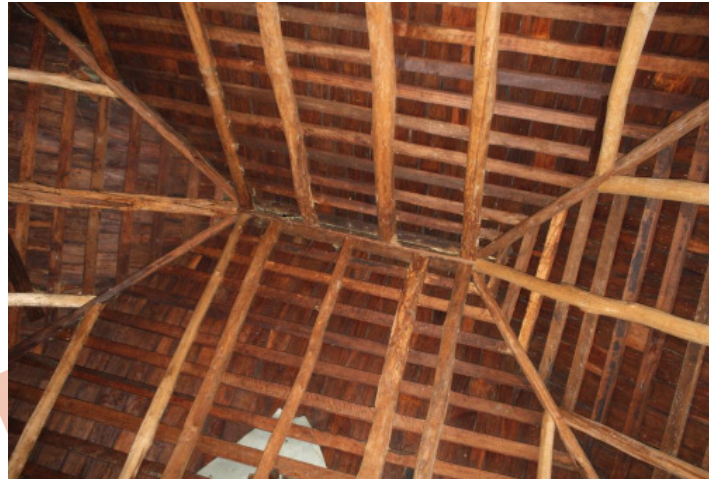
Figure 14: Looking up at the hand sawn timber framing of the main roof.

Building Element	Description	Condition	Conservation Works
Roof structure	<p>Hand hewn timber structure</p> <p>Note: evidence of earlier insect infestation damage to the vertical timber elements.</p> <p>Space between ceiling joists filled with fibreglass insulation.</p>	Fair	<ul style="list-style-type: none"> To be inspected by a structural engineer for structural integrity. The roof space is not to be used for storage, or to have any additional loads placed on it, with the exception of storing remnant ceiling lining boards from <i>Space 7 - Kitchen 2</i>. It is not acceptable to remove or alter these elements in any circumstance. Access to the roof is via small access hatch in the ceiling of <i>Space 5 - Living Room 2</i>. Insulation may be retained if desired.
Roof cladding	<p>Timber shingle roofing and support battens (underside viewed from the roofspace).</p>	Fair	<ul style="list-style-type: none"> All timber shingles and associated battens are to be retained and protected under the later corrugated iron roof. It is not acceptable to remove, alter or paint these elements in any circumstance.

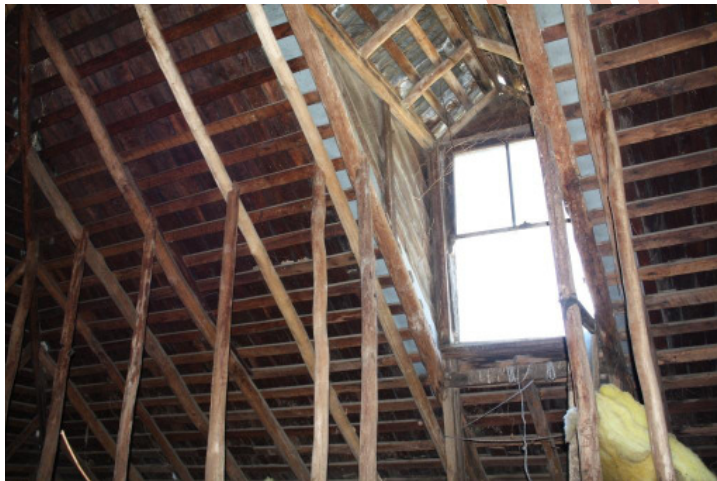
Figure 15: View of the uncut timber framing forming up the dormer roof.

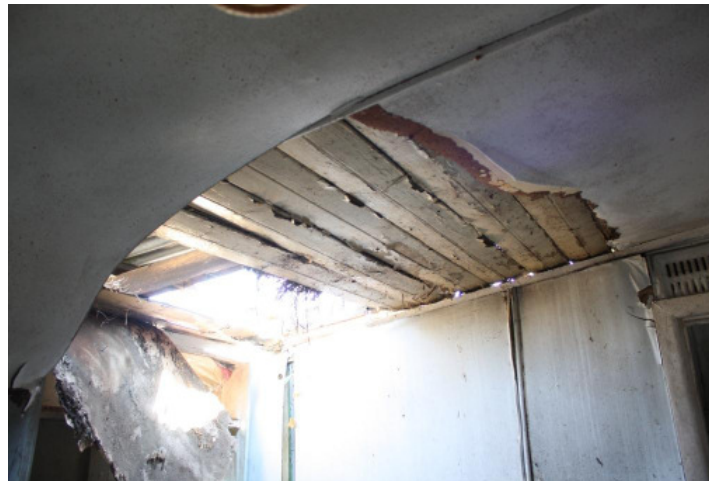
Figure 16: Space 7 - View of the earlier timber lined ceiling below the later ceiling lining.

Building Element	Description	Condition	Conservation Works
Ceiling	Painted fibre cement sheet, including battens, over earlier beaded timber ceiling lining. A portion of this ceiling has substantially collapsed.	Poor/collapsed	<ul style="list-style-type: none"> Repair works include making good the collapsed ceiling to protect the building from accelerated loss of fabric. Allow to salvage the early timber ceiling lining boards and store in the roof space. Allow to carefully stack the timber in the roof space to avoid a point load. Also, provide spacers so that the timber boards remain well ventilated.
Cornice	Timber quad moulding, painted.	Fair/poor	<ul style="list-style-type: none"> Repair and repaint.
Wall	Painted fibre cement sheeting, cover batten strips.	Poor	<ul style="list-style-type: none"> Repair and repaint.
	Built in timber shelving (built into the space beside the chimney).	Poor	<ul style="list-style-type: none"> Repair and repaint if desired.
