STRUCTURAL ENGINEERING REPORT

Policeman's Cottage

Reservoir Road, Prospect NSW

Job Number: 14391
15th July 2014

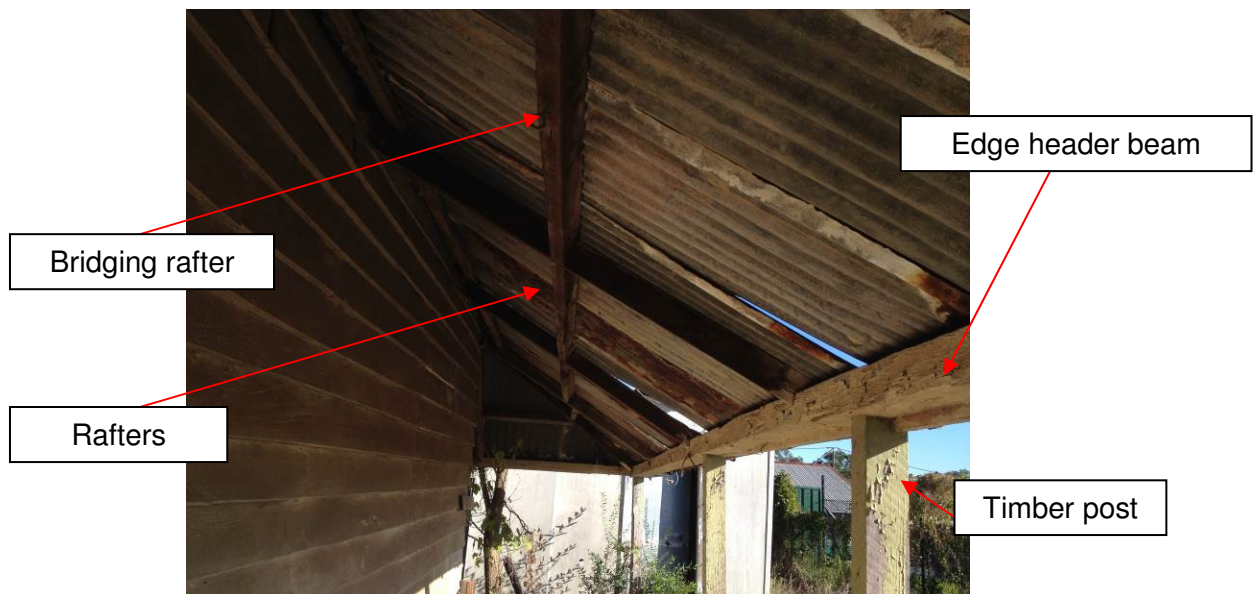
The external timber frame verandah comprises 90x90mm hardwood posts, header beams around, 90x50mm hardwood or Oregon rafters and same size bridging member in between as shown in Photo 1 below. Most of the rafters are spaced at approximately 2000mm centres.

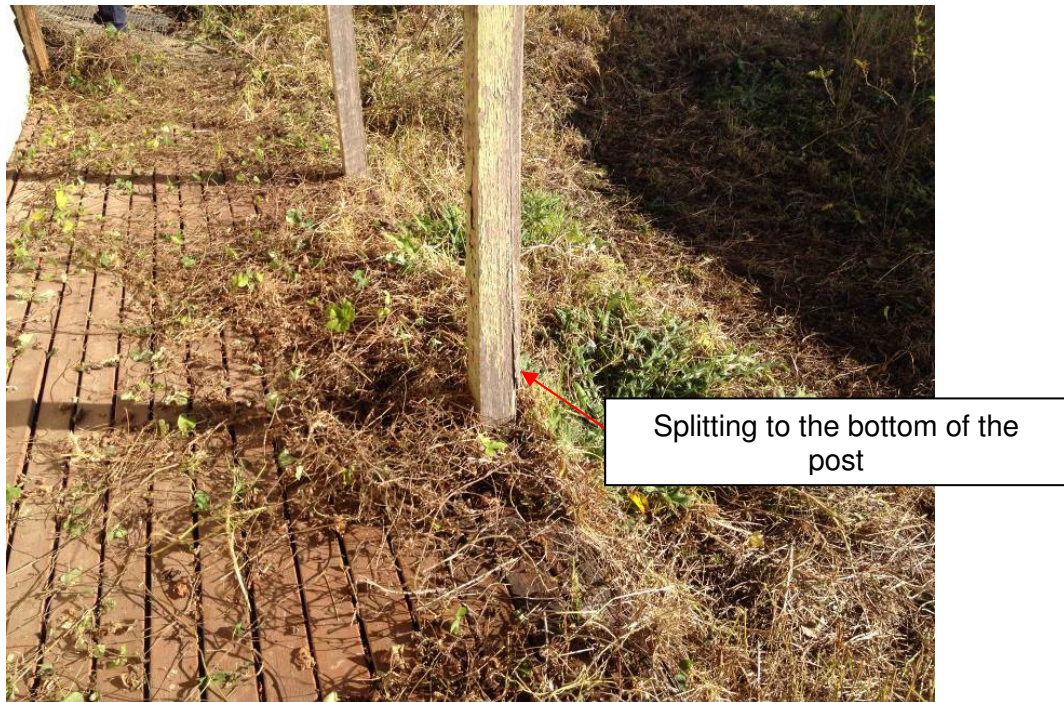
The condition of the timber post varies from extensive weathered to aged with wood rot; some of the posts are leaning due to the condition of footing below or missing.

Most of the posts show signs of wood rot, splitting and deterioration as shown in Photo 2 below.

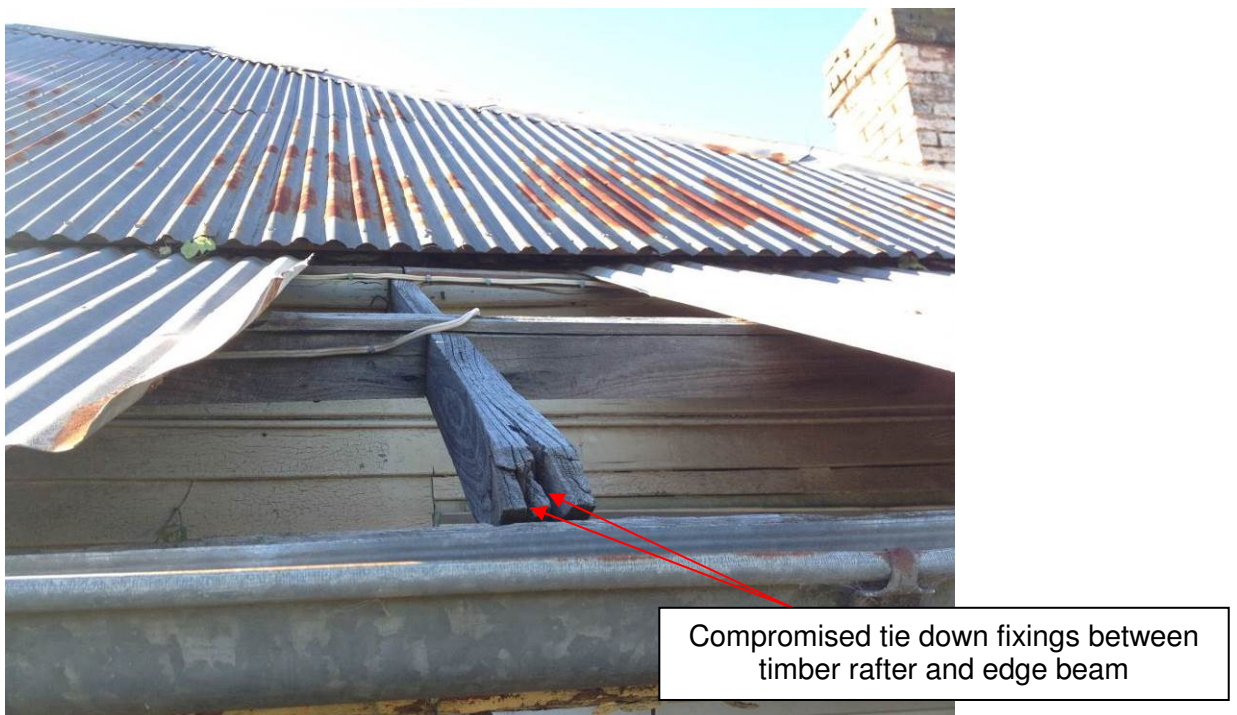
Most of the rafters are showing signs of deterioration and the tie down fixings have compromised due to corrosion as shown in Photo 3 below. We believe some connections have lost the full tie down capacity.

The structural condition of the timber framed verandah is in poor condition. Immediate attention is required in order to prevent any sudden collapsing. It is our opinion that most of the tie down connection between timber edge beam and rafters are not adequate due to corrosion and timber decay; therefore the risk of verandah roof collapsing is high.

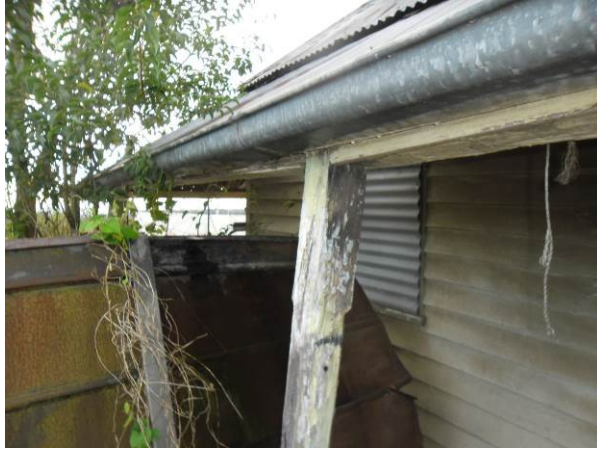
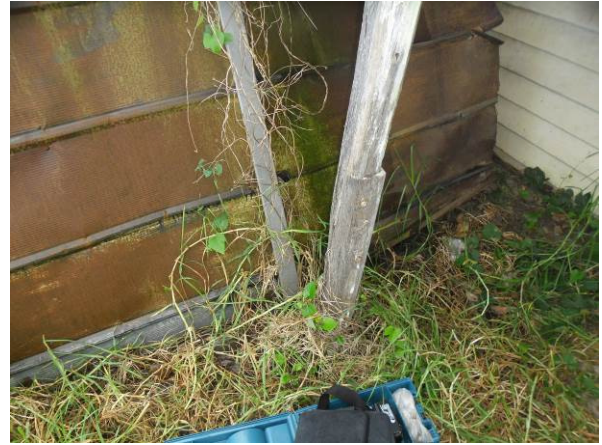
The timber post adjoining the entry door to the western elevation is noted to be out of plumb excessively as shown in Photo 4 & 5. If this timber post keeps leaning away, there is a potential risk of localised collapsing of the verandah roof.

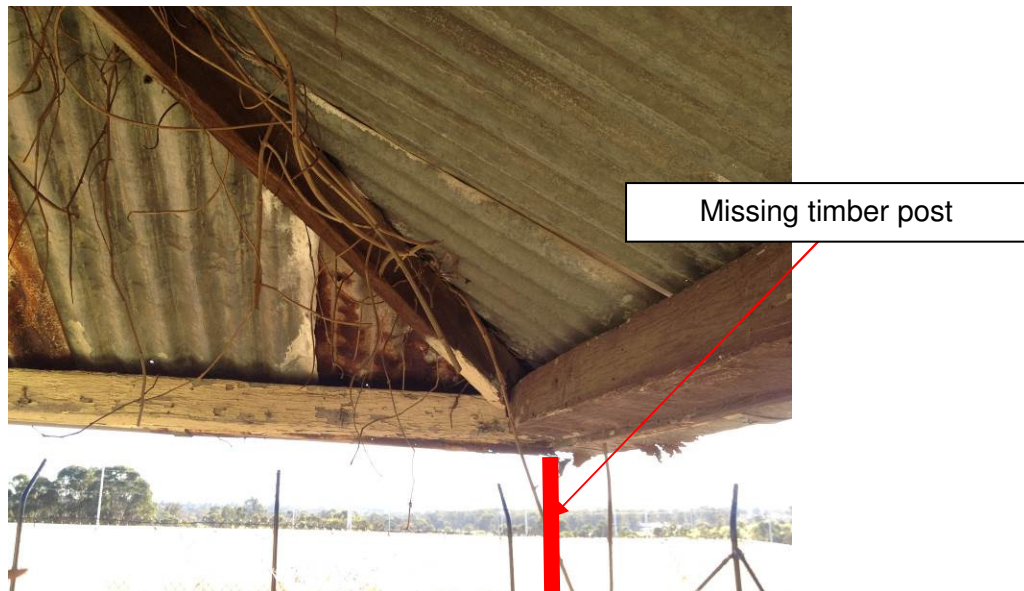
Photo 6

A timber post is noted to be missing at the northeast corner of the verandah as shown in Photo 6. The roof shows evidence of excessive deflection at this location; it is our opinion that this may potentially cause the roof to fail partially due to the wind uplifting because there is no tie down provided without the post. This has also caused excessive deflection and eventually would cause the roof to collapse.

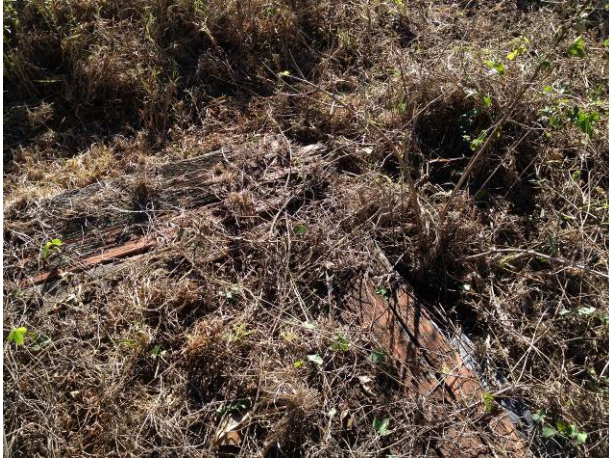
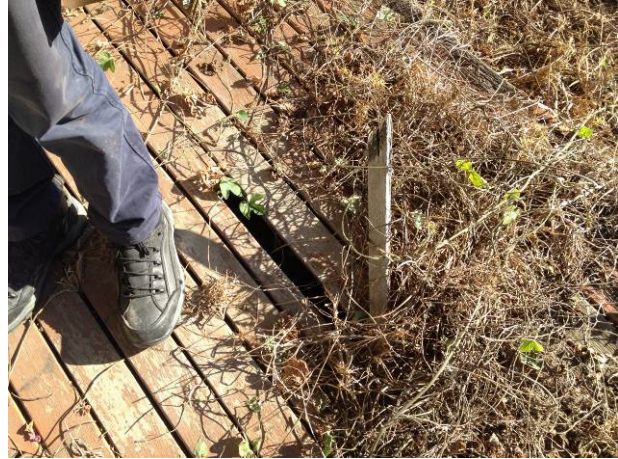
The existing timber decking at the northeast corner of the verandah has deteriorated excessively as shown in Photo 7 & Photo 8 below. The decking is supported by 90x50mm bearers and joists. The forestry inspector has failed to provide a strength grade on them due to their poor condition. The entire decking at this corner is unsound in its current state.

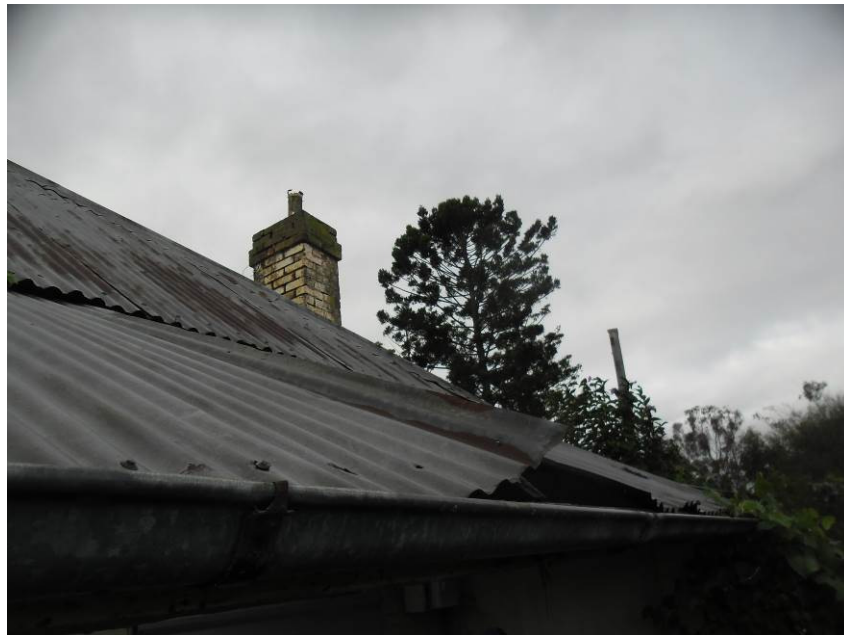
*Photo 9*

The roof sheeting for the verandah has corroded over the years and is in poor condition as shown in Photo 9; the roof screws are missing at multiple locations throughout the entire area, this is a high potential risk for public safety under windy condition as the roof sheet may be ripped off.

Loose metal roof sheeting has the potential to rip off in strong winds and would cause continuing decaying to the internal timber members due to presence of moisture.

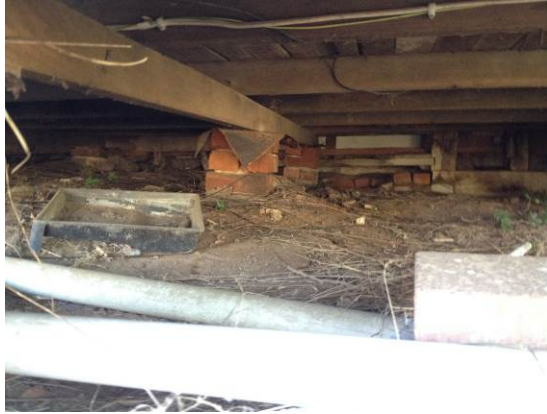
The entire policeman cottage has timber floor framing throughout; the floor bearers for the southern kitchens are supported by 230x230mm brick piers as shown in Photo 10 below.

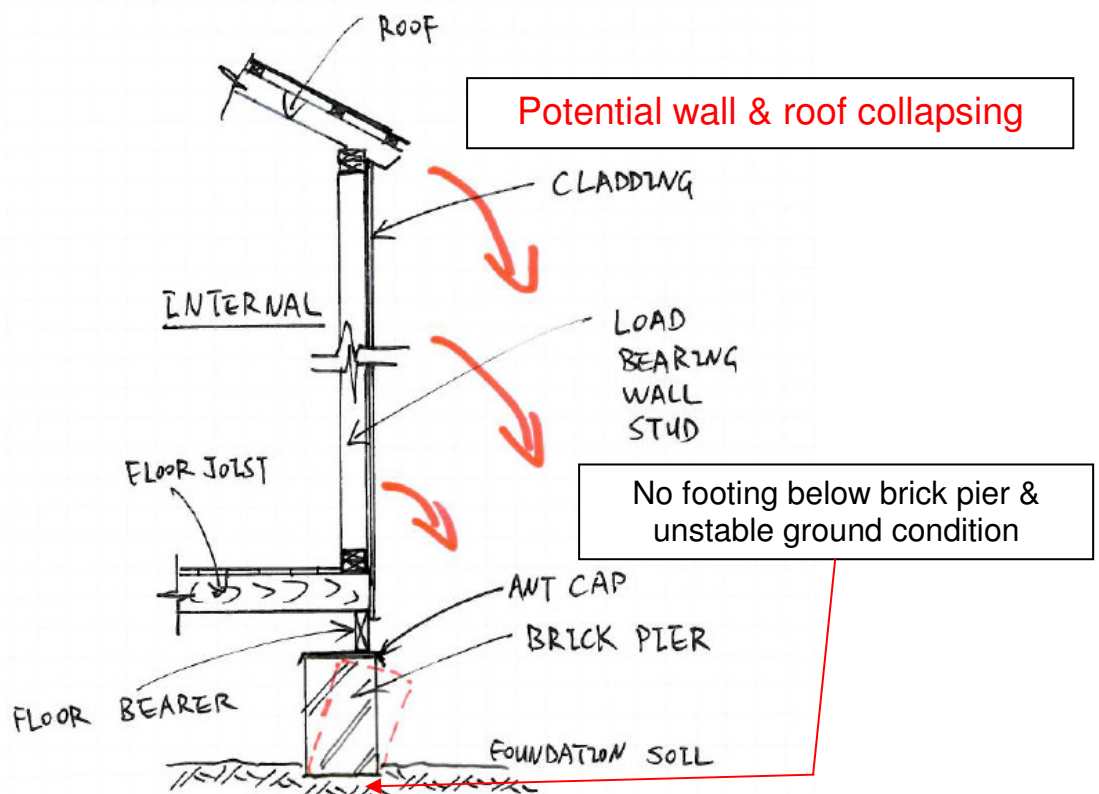
Figure 2: Consequence of leaning brick pier

Multiple brick piers are noted to be leaning as shown in Photo 11; excessive deterioration to the mortar joints is evident. It is our opinion that the integrity of these brick piers has been compromised due to the low bearing capacity of the foundation material and the condition of the brick piers. There is potential risk of structural failure of the timber floor frame and load bearing stud walls supporting the roof for this section of the cottage. A schematic is shown in Figure 2 below to show the consequence of this.

It is our opinion that the integrity of multiple brick piers has already been compromised due to aging and subsidence. This is an immediate safety issue as the flooring, loadbearing walls and roof may partially collapsing.

The brick pier footings and timber framed veranda are far beyond repair; the main roof frame may be retained and should be dismantled, treated, strengthened & conserved if it has any heritage significance.

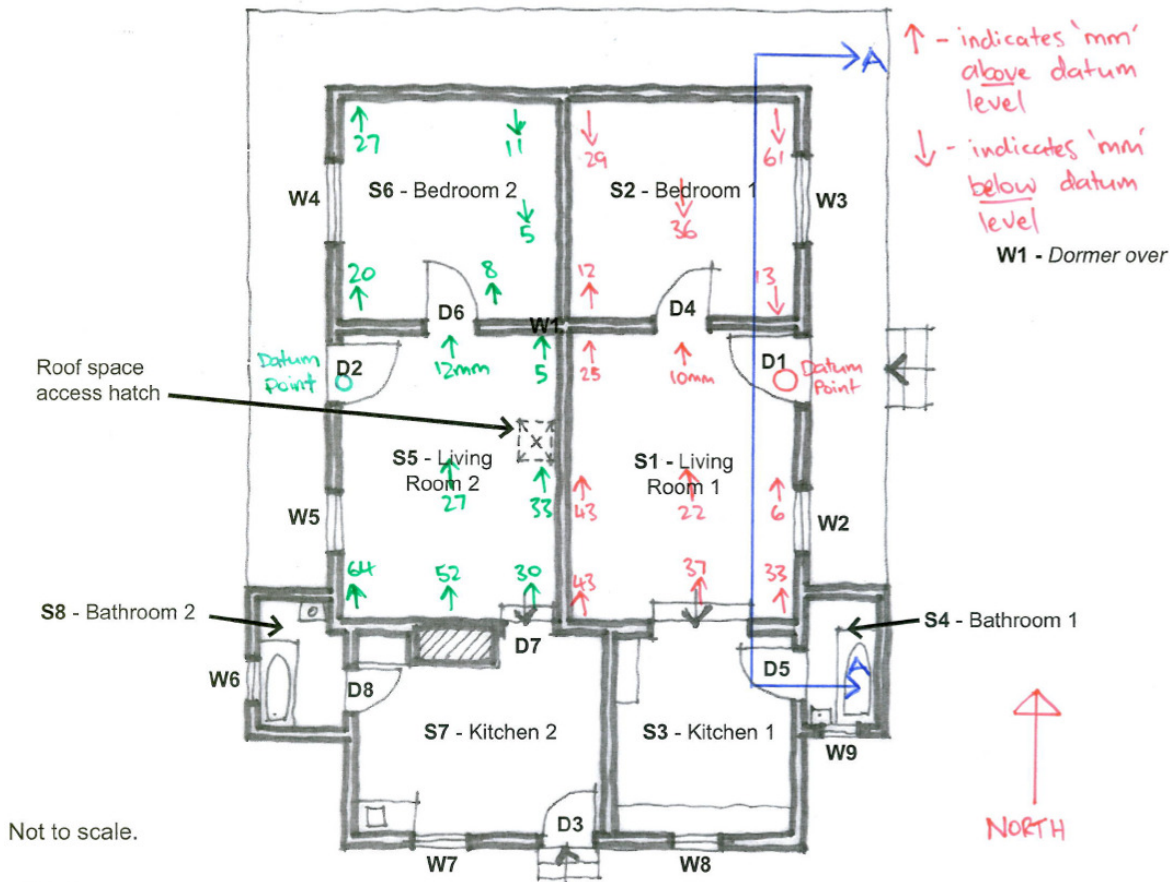
Figure 3 – Floor Level Readings

There is likely foundation subsidence throughout the entire cottage as the internal floor level is not leveled; a settlement of up to 90mm was measured during our inspection by using a surveying equipment.

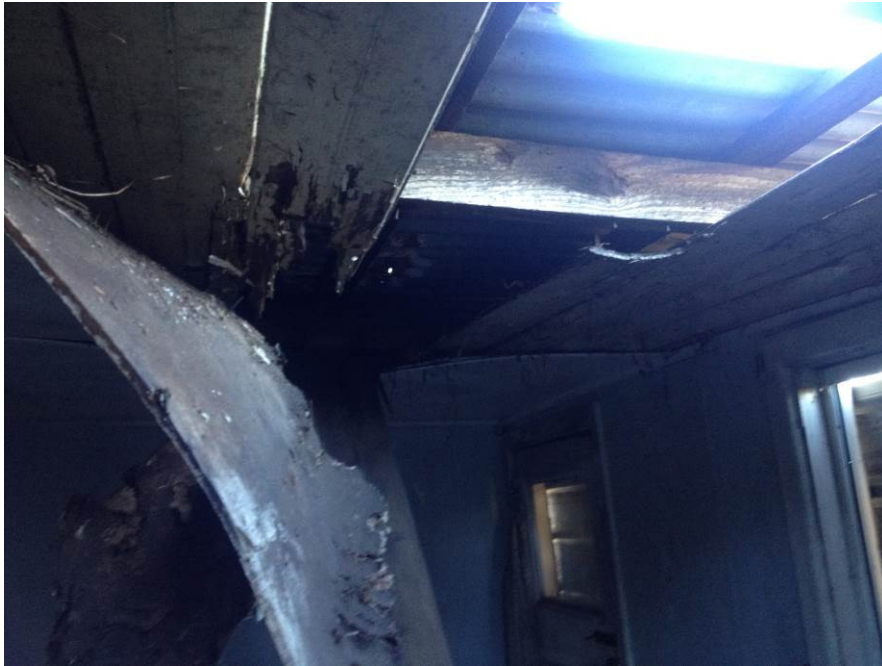
Photo 11

The ceiling of the western kitchen has been completely damaged due to the water ingress as shown in Photo 11; it is our opinion that this is not safe and there is risk of ceiling collapsing due to prolonged period of water ingress.

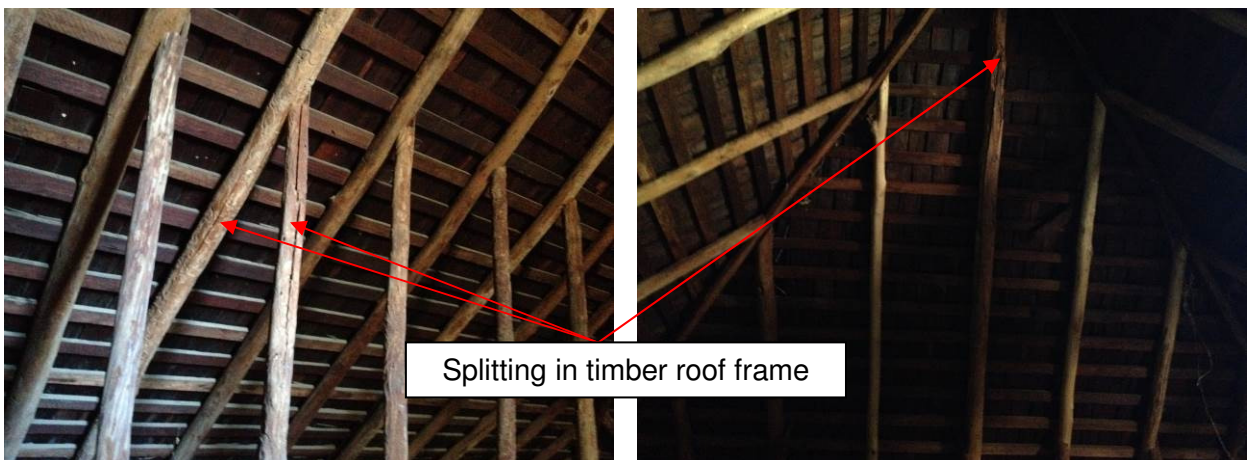
The roof consists of hardwood rafters and rafter struts which are from round small growth trees varies from 50 to 120mm in diameter. The forestry inspector has identified termite and lyctid borer damages to this roof frame. Splitting and/damage to timber frame is evident at multiple locations as typically shown in Photo 12 & Photo 13.

Evidence of termite damage was noted by the forestry inspector as noted in their report attached in the Appendix of this report. Multiple rafters and vertical struts are showing signs of excessive splitting; therefore it is our opinion that some timber elements may have lost their structural capacity.

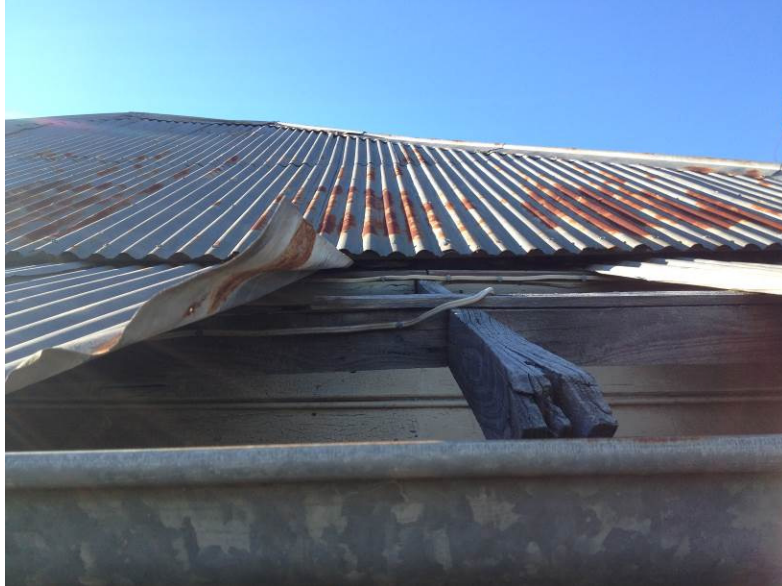
Photo 14

The existing corrugated roof sheet shows evidence of corrosion at multiple locations throughout as shown in Photo 14. Corroded & missing roofing screws make this a potential public safety issue.

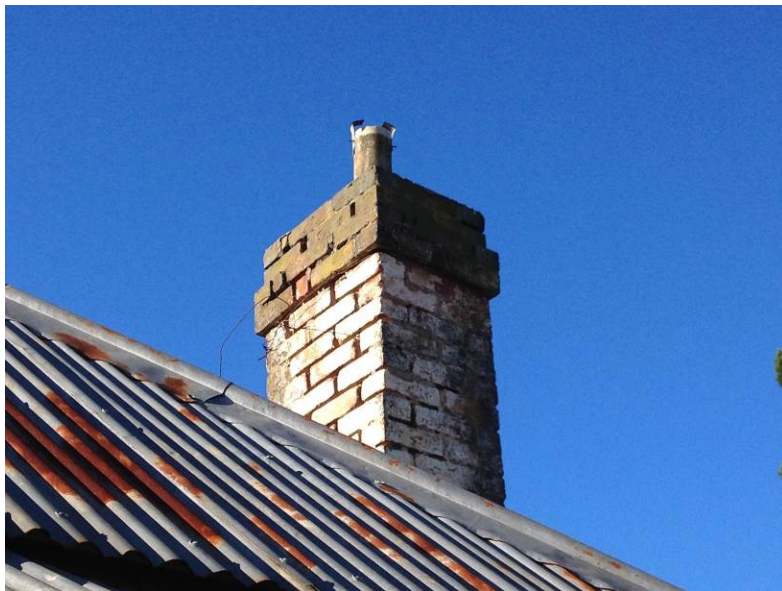
There is a brick chimney located towards the southern elevation of the cottage as shown in Photo 15 below.

Mortar joints are noted to be severely deteriorated due to aging & weathering of the lime mortar. This has increased the risk of structural failure of the brick chimney.

The exposed brick chimney above the roof level shows excessive deterioration of the mortar joints and it is our opinion that the structural integrity of chimney has been compromised.

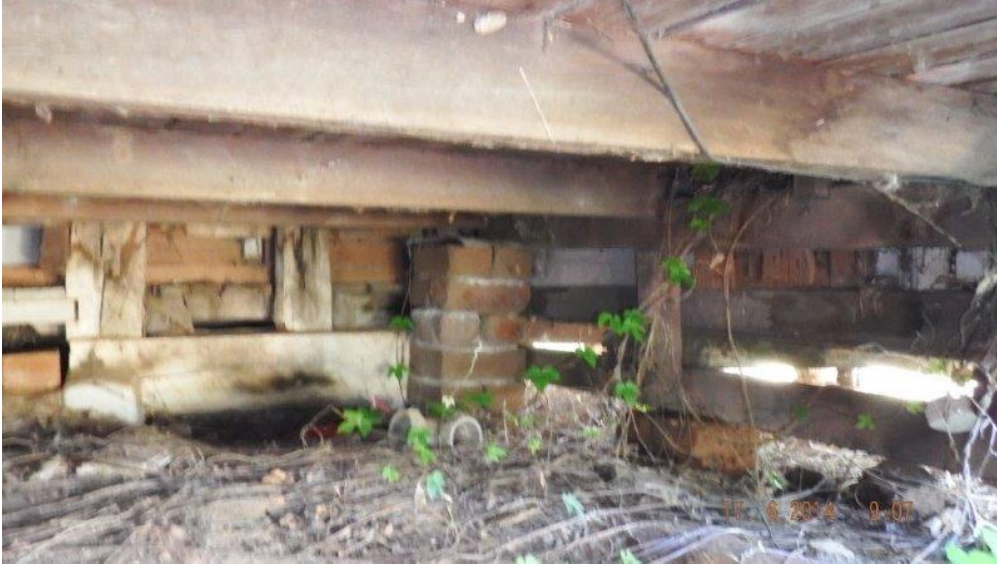
Photo 1

- 3.2.1 The only subfloor access was under the room marked S3 Kitchen. The bearers and joists were hardwood 95mm x 50 mm nominal and except where detailed on the plans met the grade requirement of F17.

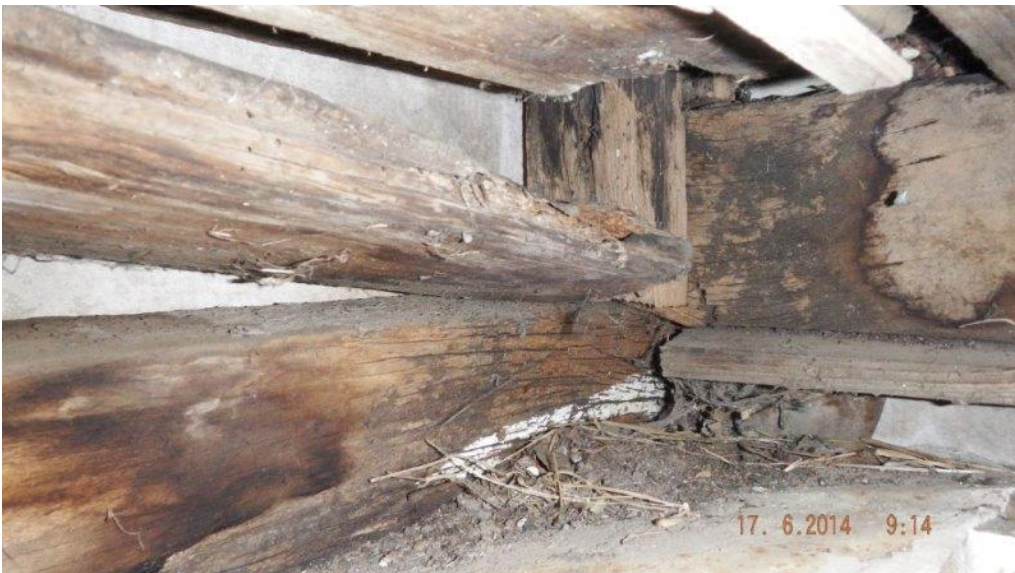
Photo 3

The joists were spaced at 700mm centre and the bearer spacing was 1800mm centres.
The joist and bearer was decayed under one corner of the room.

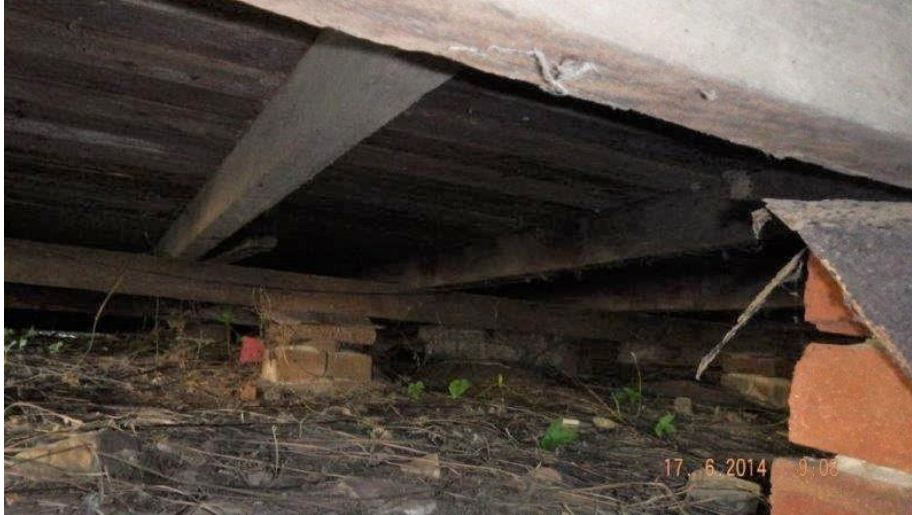
Photo 2

- 3.2.2 The bearers and joists under the room marked S7 – Kitchen could be viewed from the surrounding grounds and from under room S3. Some decay was observed in the bearers above piers.

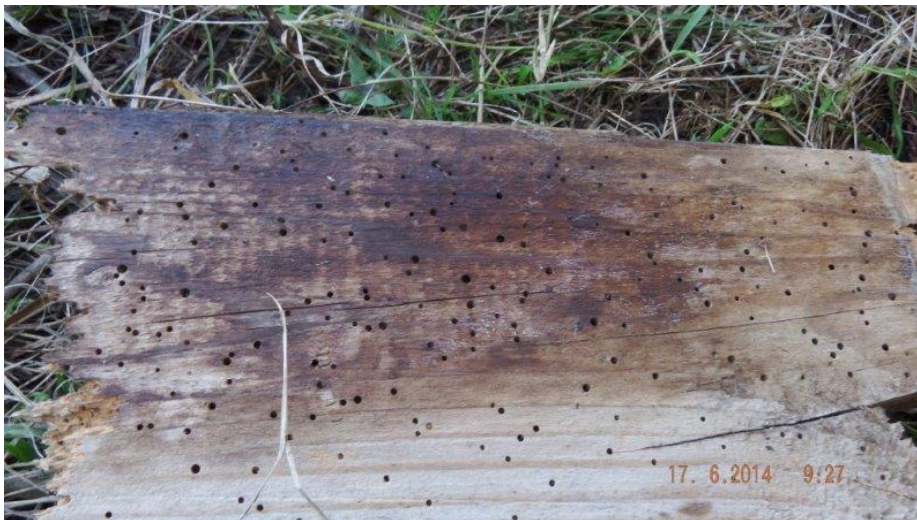
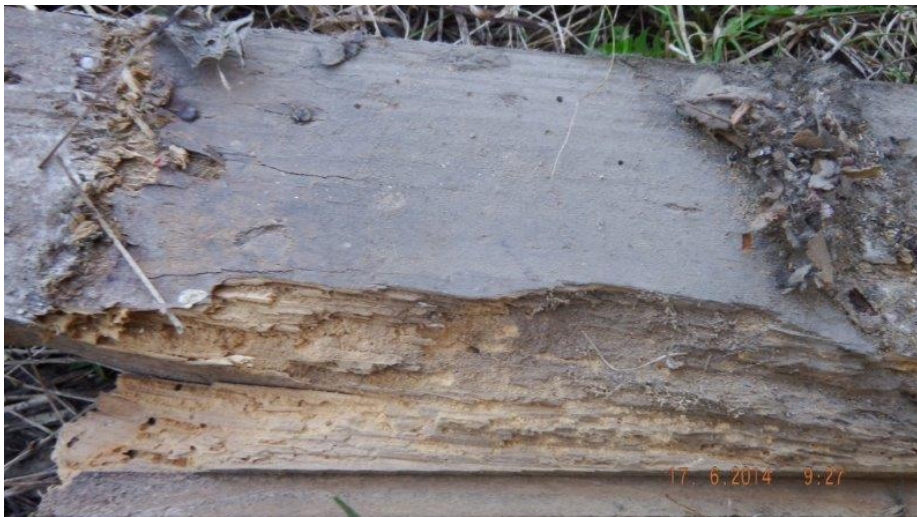
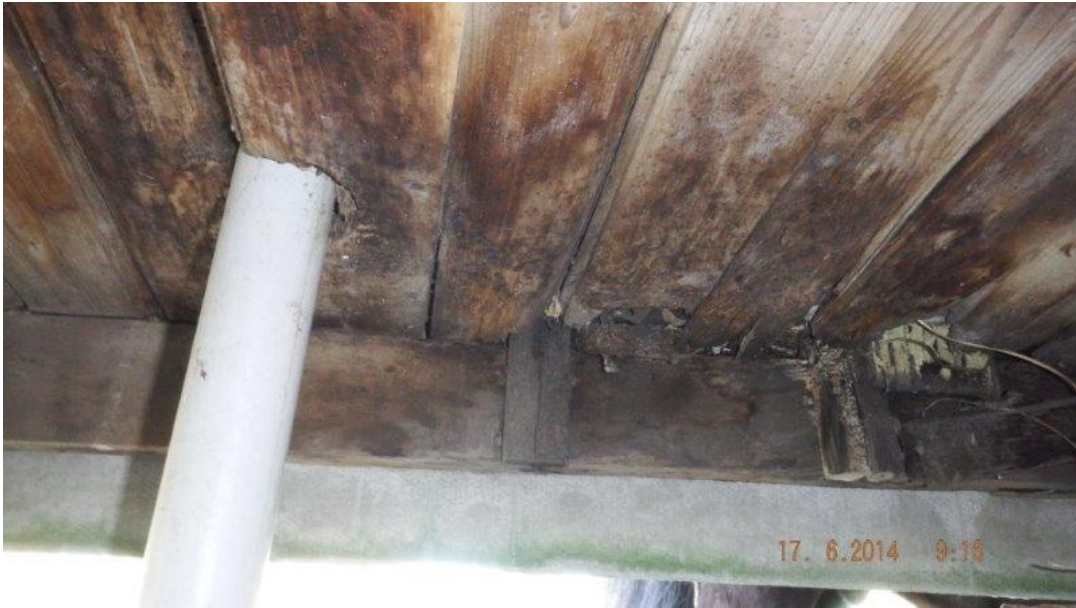
3.2.3 Flooring under S3 and S7 was softwood and was badly affected by Anobium borers. It may not be serviceable.

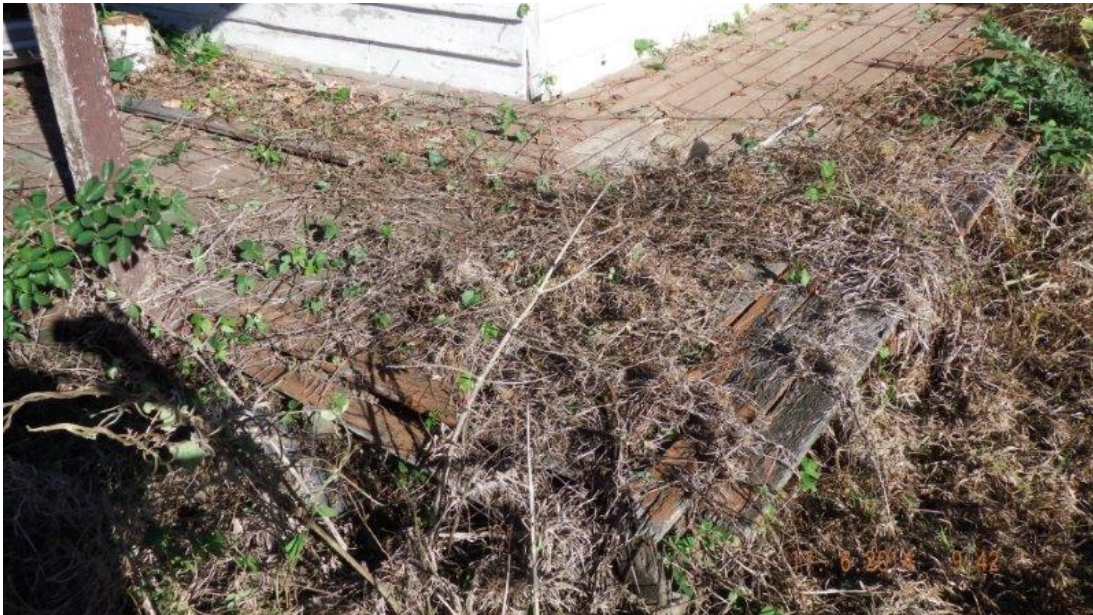
Photo 14

- 3.2.4 Subfloors under verandahs on the eastern and northern sides were viewed from the grounds and from above. Bearers and joists were 90mm x 50mm. Joists appeared to be at approximately 700mm centres. The timber was in poor repair and most members had slight to extensive decay. They were not graded.

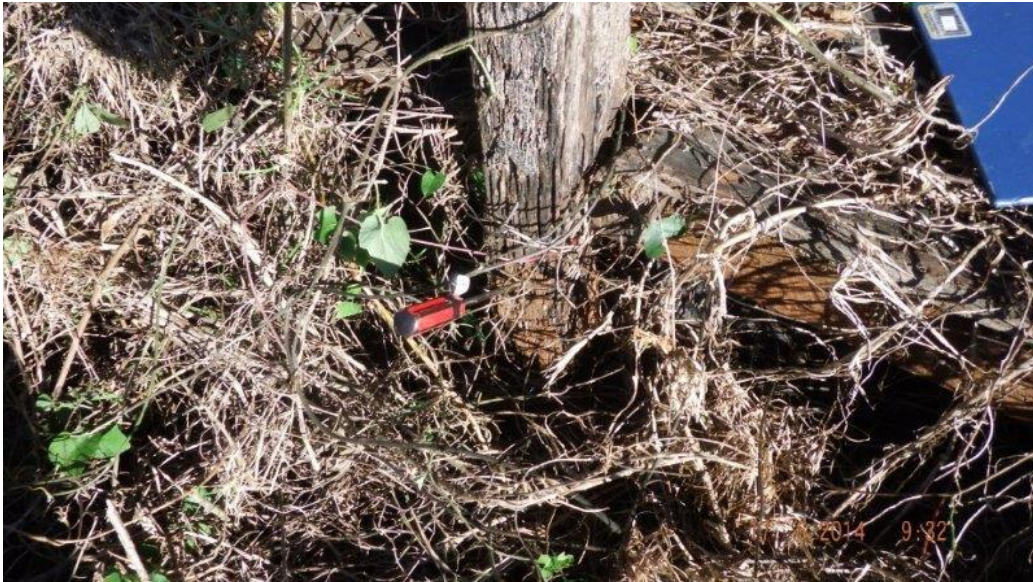
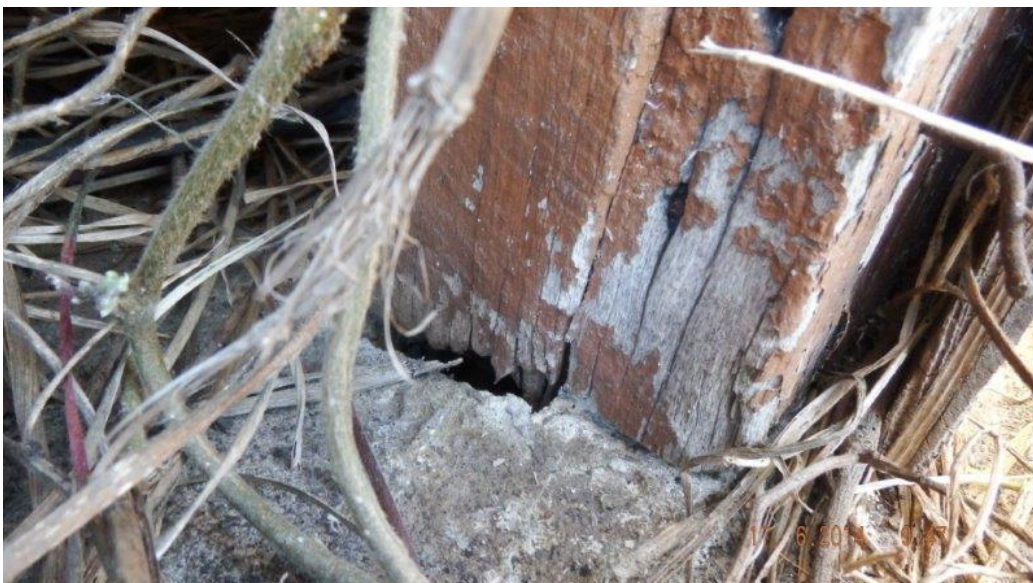
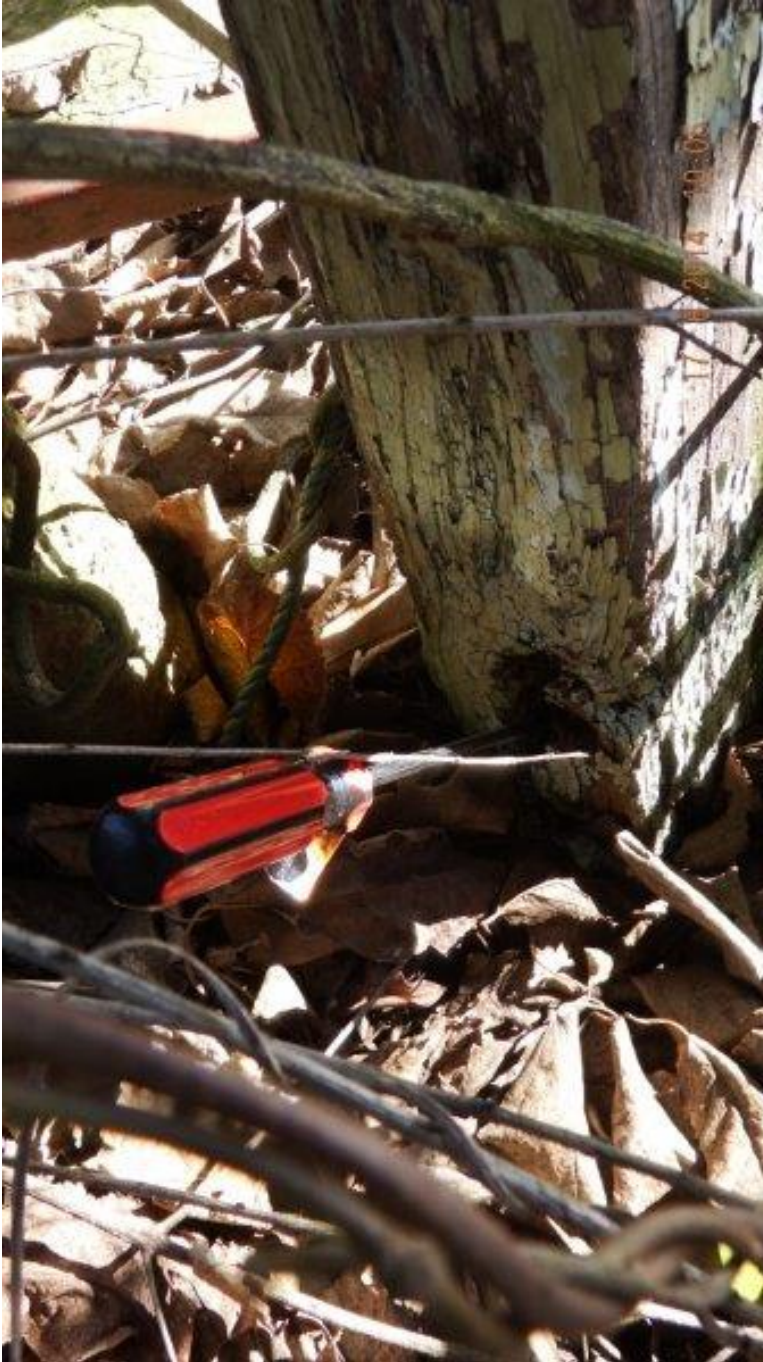
3.3.2 The verandah was supported by hardwood posts and Lintels. That were 90mm x 90mm approximately. The verandah posts were not graded as they were decayed above and in contact with the ground. One post was made up of splicing two sections together. The posts were often considerable distances apart. Some were missing including one which leaves the north east corner of the verandah roof unsupported.

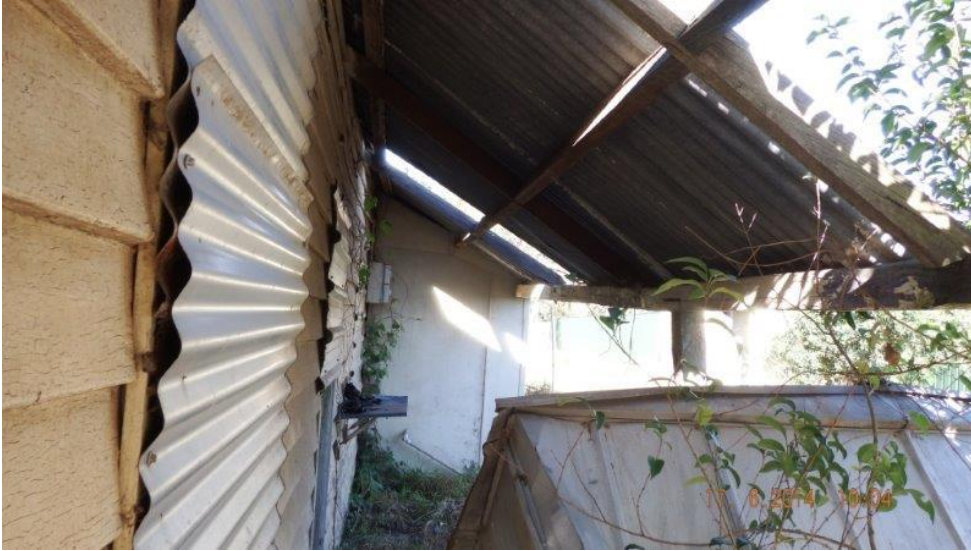
Photo 16

3.3.3 The rafters were 90 x 50mm. The spacing between, in most instances, were approximately 2000mm however some were greater. There was a spacer mid span between rafters that was the same size. Some rafters were of low strength group 3 hardwood and some were Oregon. The grade of the hardwood rafters where they could be seen was F14 and the Oregon where it could be seen F7.

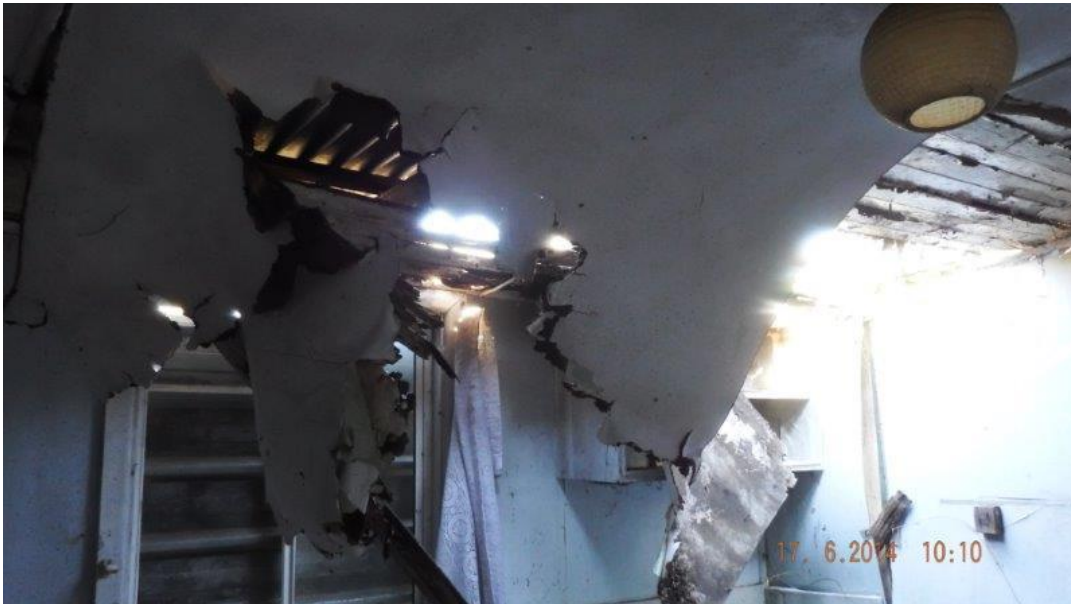
Photo 18

- 3.4.1 In Room S7 part of the ceiling had collapsed revealing Oregon Rafters. There was some decay in these exposed rafters. The rafters were 100 x 50mm and were spaced at 1100mm centres.

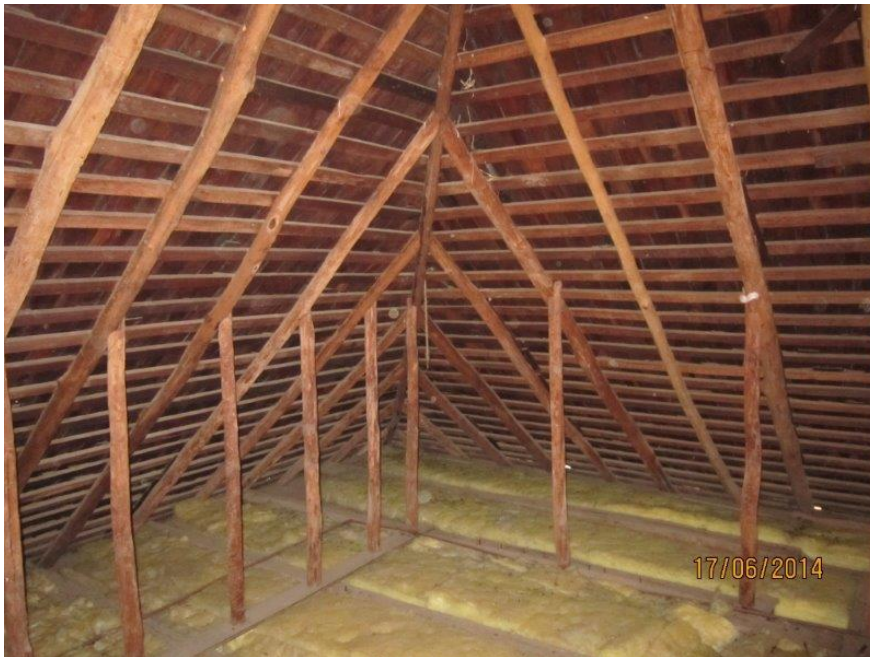
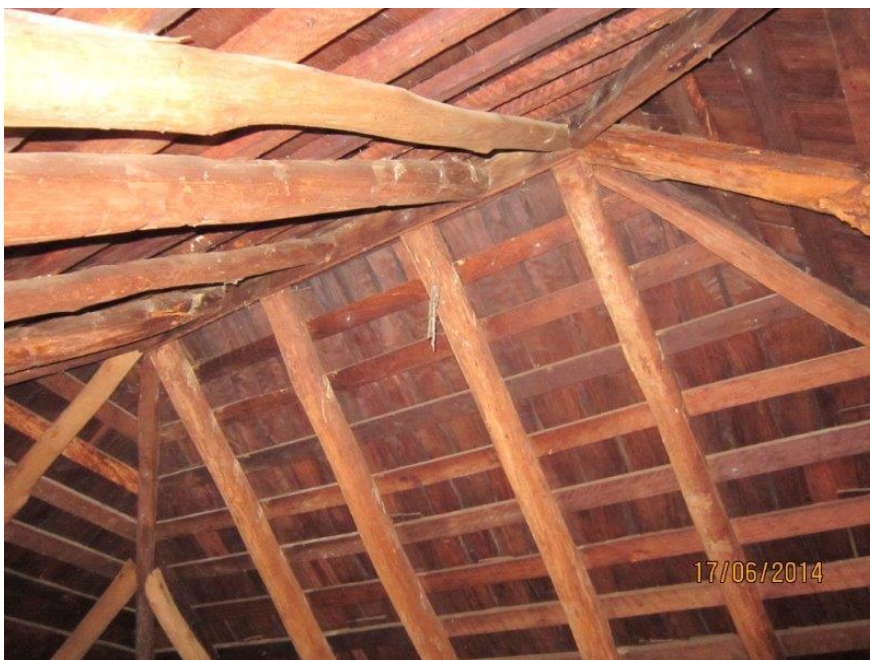
3.5.1 The roof consisted of rafters and rafter props that were hardwood. The rafters and props were from round small growth trees from about 50mm in diameter to 120mm in diameter. They were spaced at approximately 450centres. The species could not be identified however the species was mixed and reasonable dense. There were considerable defects in many of the rafter including limbs, termite damage, overgrowths of injury' splits and Lyctid borer damage. The rafters and props were not graded.

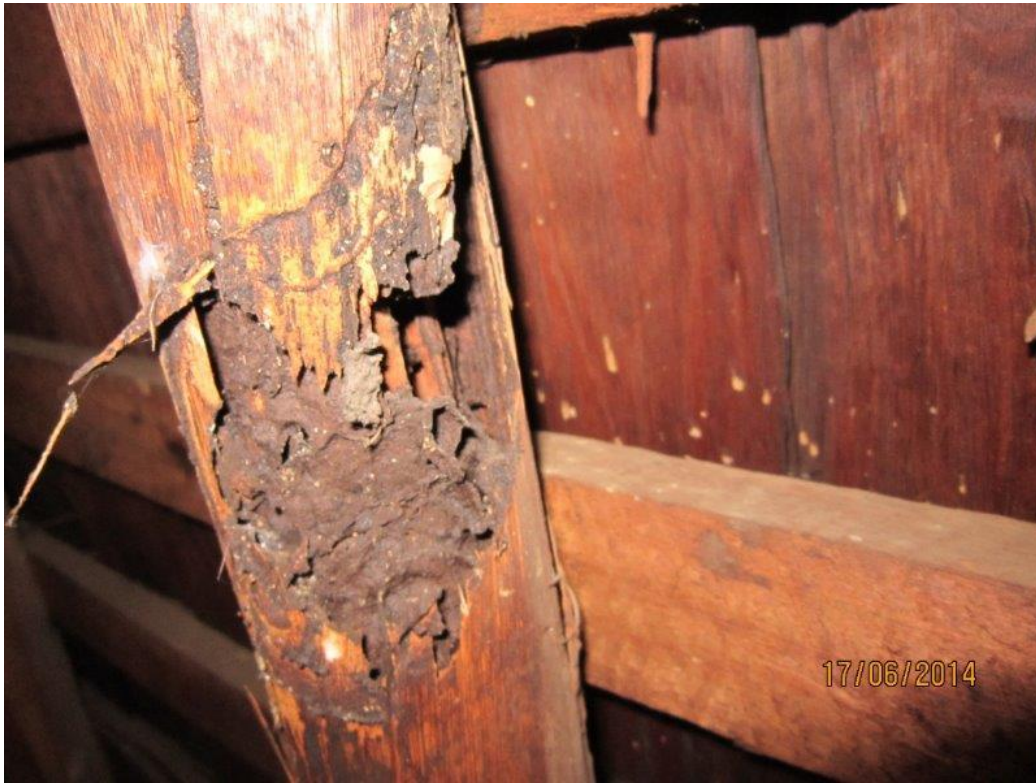
Photo 23 Termite damage.

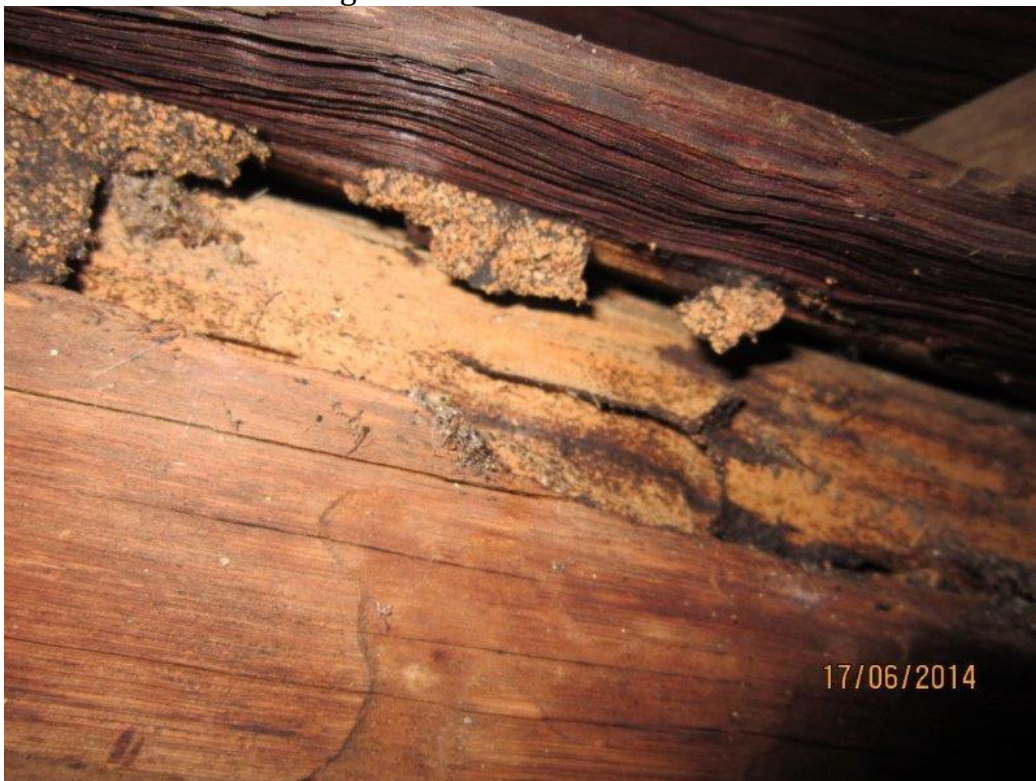
Photo 24 Termite damage

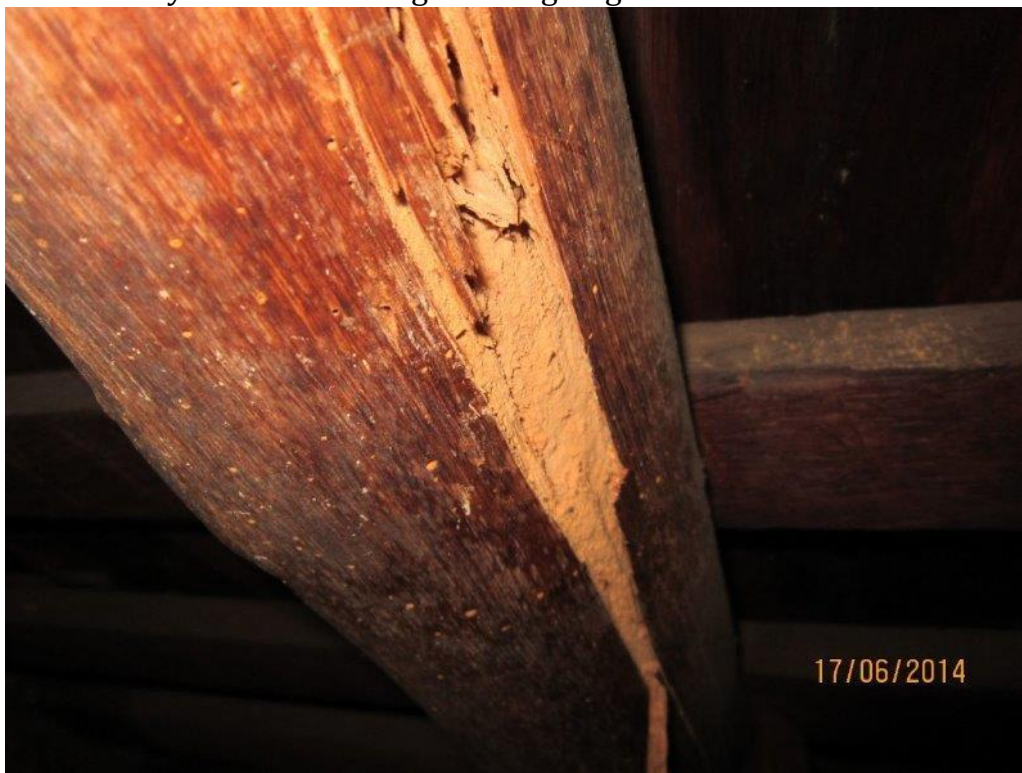
Photo 28 Lyctid borer damage turning large sections of the timber to dust.
