PROPOSED REDEVELOPMENT

**7-9, 11-13 & 15 RANDLE STREET,
SURRY HILL, NSW**

HERITAGE IMPACT STATEMENT

September 2019

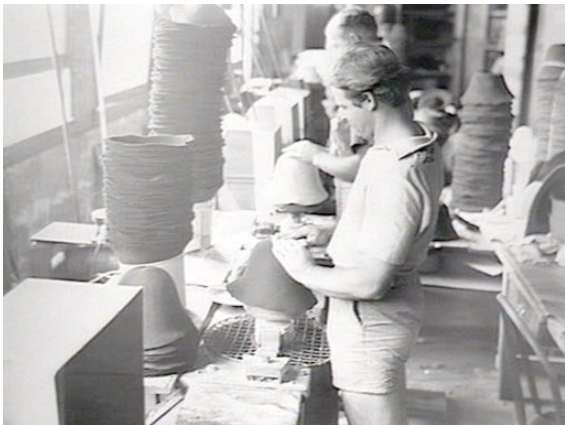
Figure 2.6 The second stage in the sanding of felt hat to remove any irregularity or blemish. March 1949

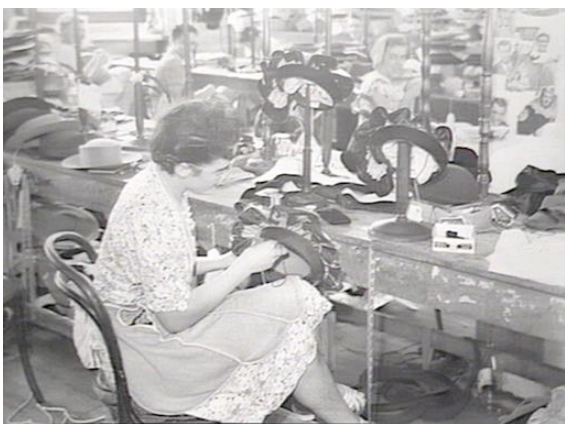
Figure 2.7 Final finishing and trimming a hat, March 1949

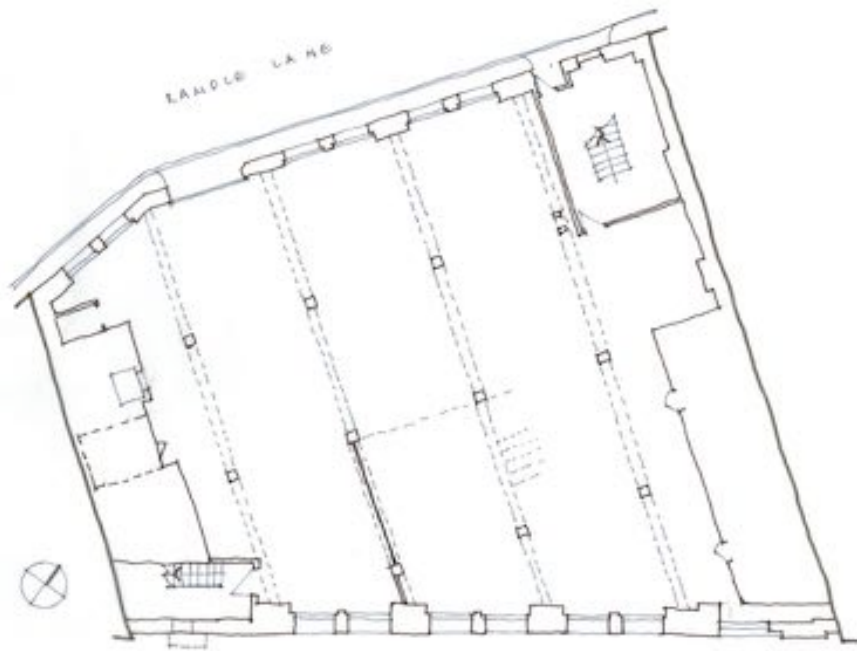
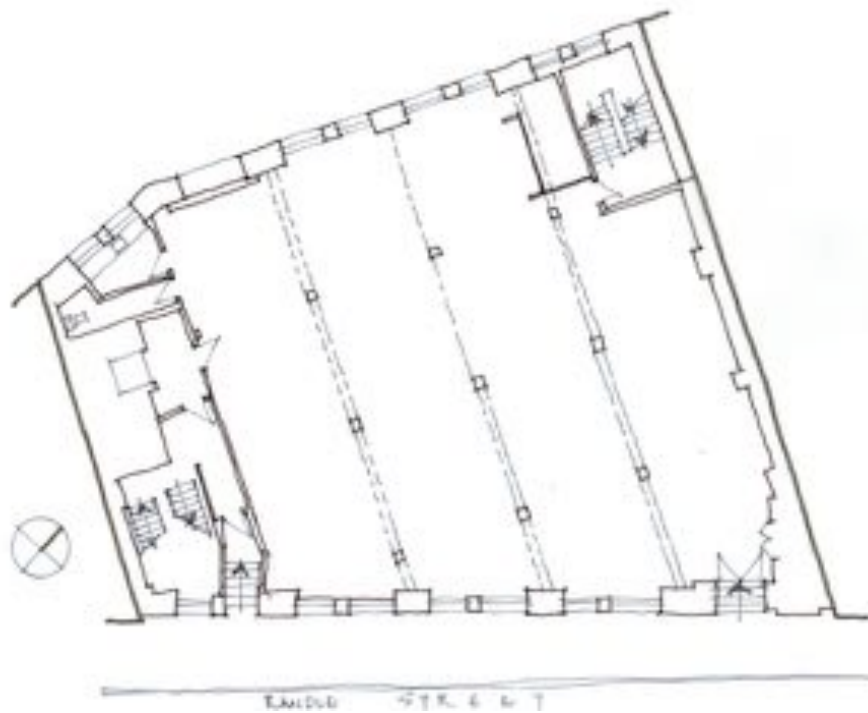
Figure 3.1 11-13 Randle Street, Surry Hills

Plans as existing

The floor plan of the building generally repeats at each level with a large area of open space to the north and a service stair, lobby and lift to the south. The original lift shaft remains but has been replaced with a modern lift to the side. At some levels there are original lavatories to the southwest corner.

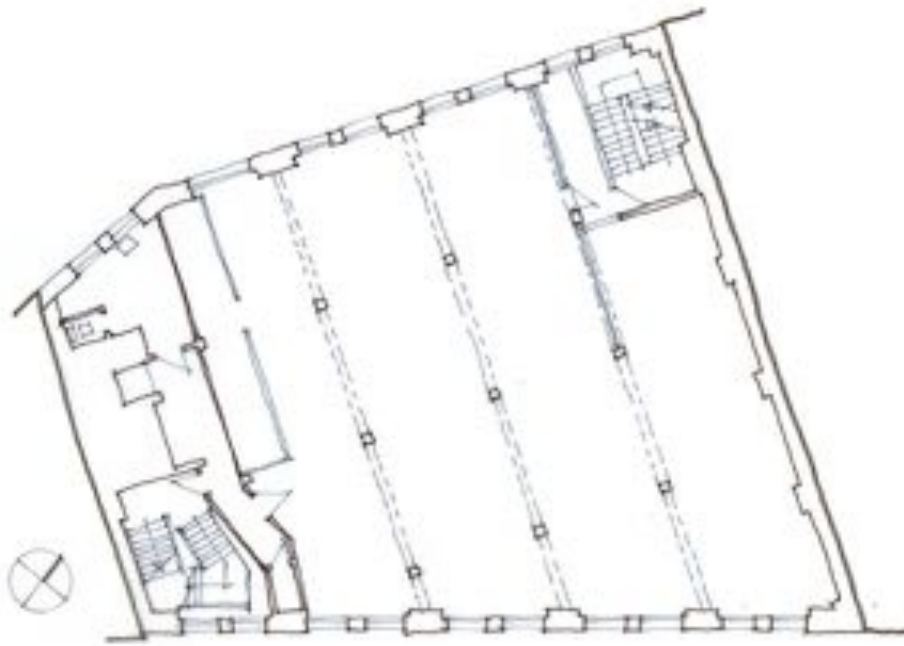
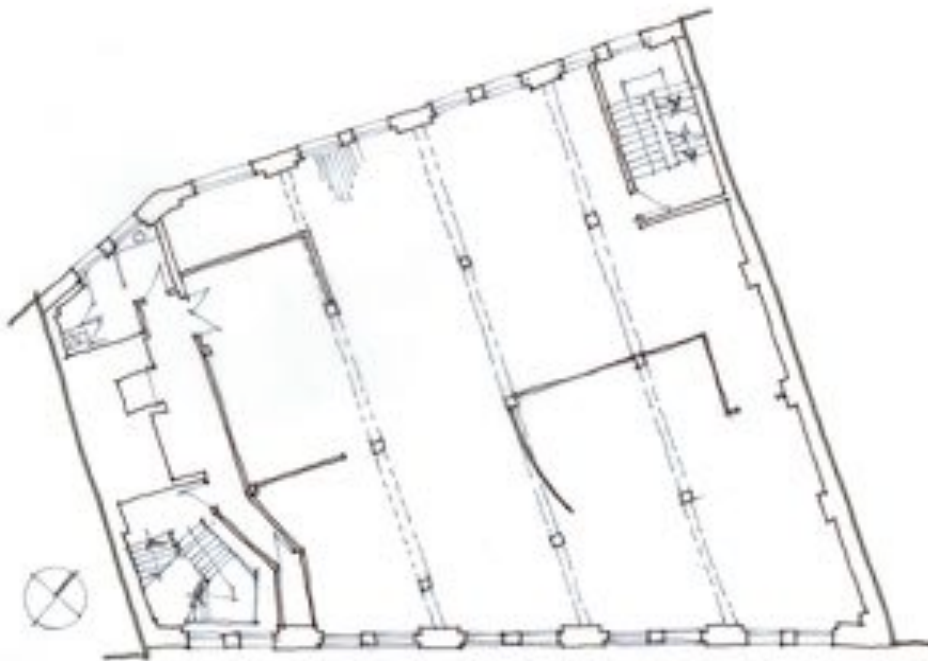
Figure 3.2 11-13 Randle Street, Surry Hills

Plans as existing

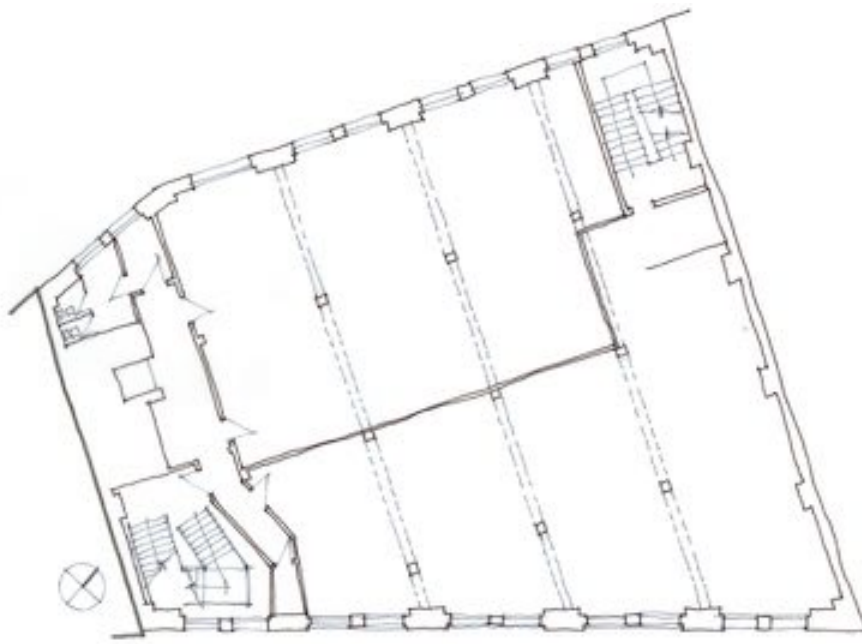
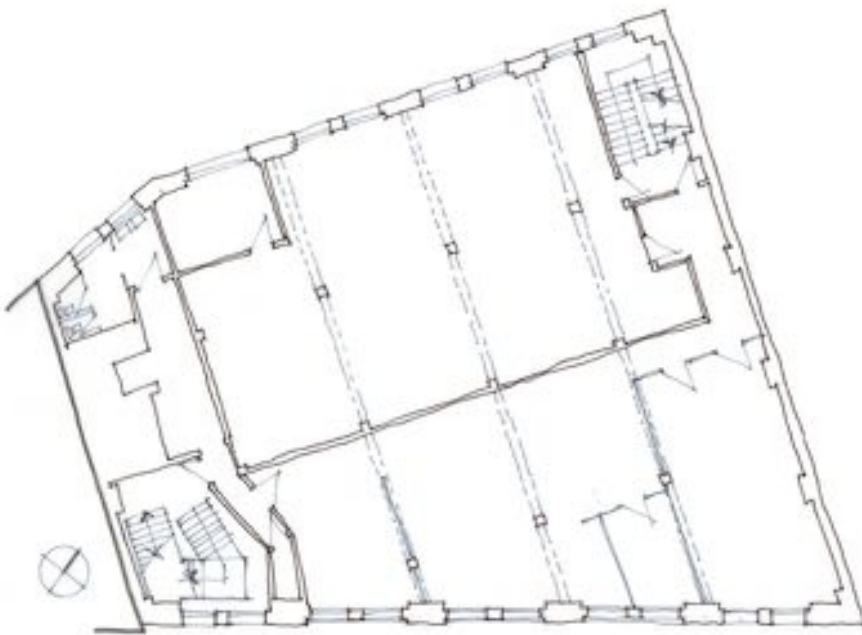
Figure 3.3 11-13 Randle Street, Surry Hills

Plans as existing

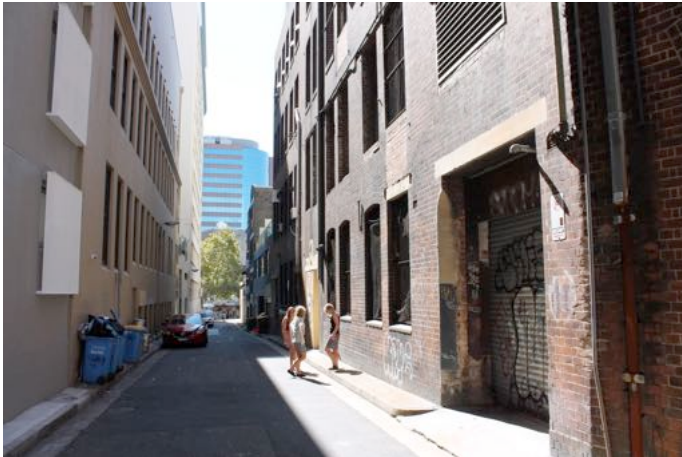
Figure 8.1 Rear elevation to Randle Lane

There is very limited change to the elevations apart from at the lower ground floor at Randle Lane where this is justified by the change of use and the activation of the rear lane.

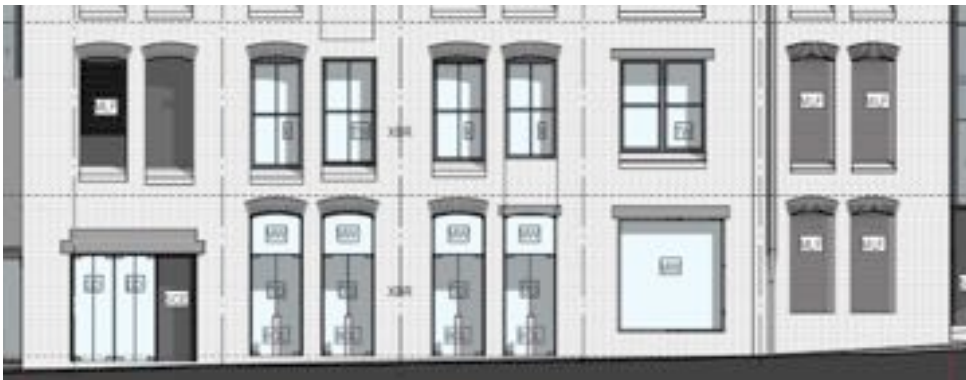
Figure 8.2 Proposed treatment to Randle Lane

The works to the ground floor windows involve the removal of the brick spandrels and insertion of steel windows between the existing jambs and head. The loading dock door will be partly infilled and the door replaced with glazing. The second loading dock door will be replaced with a display window.

Non-original windows above will be replaced to the common, original detail with selected windows replaced with louvres for air make up. The rear façade is very robust and the changes are sensibly considered and carefully controlled to limit the extent of change while conserving the majority of the elevation above.

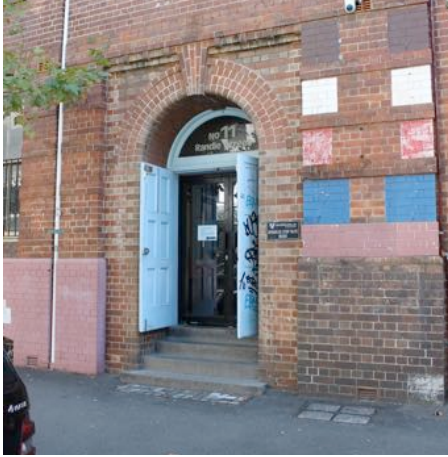
Figure 8.3 Main entry door

The main entry to the building was to Randle Street and this remains though the majority of the building is accessed from a later door to the south.

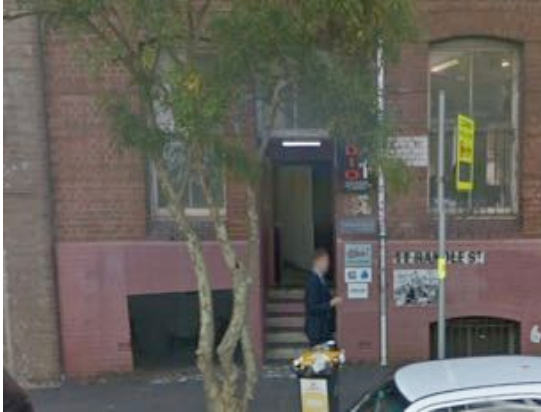
Figure 8.5 Later opening to Randle Street

New openings are required for fire booster assemblies that are required to be set at the footpath. The openings are to the altered section of the ground floor facade to Randle Street where the later opening has been inserted.

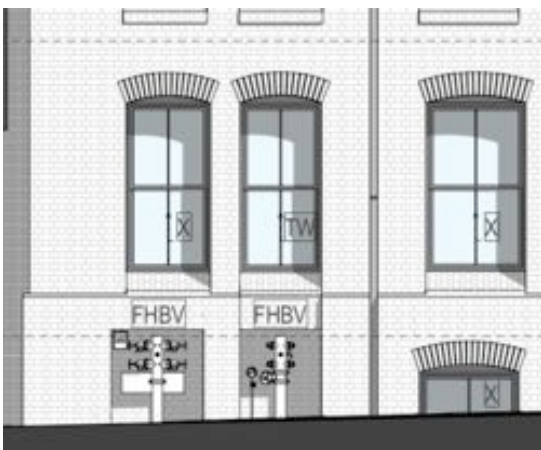
Figure 8.6 Proposed treatment

The later door opening will be partly infilled and the original window reinstated. The building has openings to the basement and the proposal repeats this but does not match the arches to signal that the changes are modern.

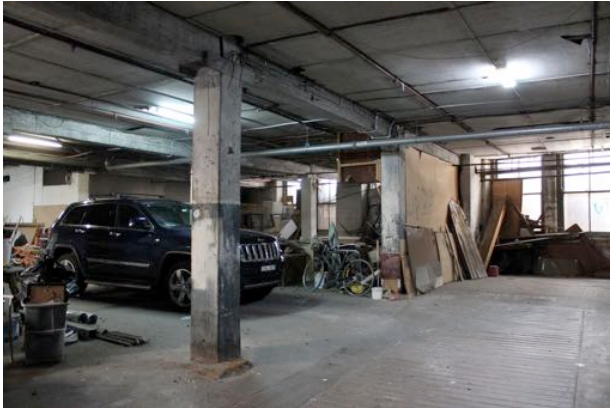
Figure 8.7 Basement structure

The basement timber structure will require temporary removal to allow for piling but this will be reinstated on completion of the new floor structure. A structural methodology has been developed for these works. The lower sections of the columns have been affected by white ant damage and will be replaced with concrete plinths.

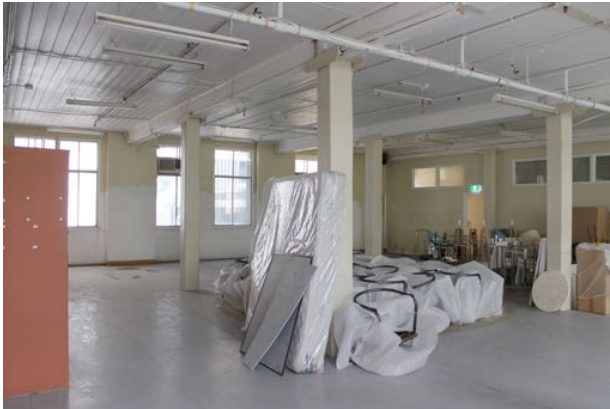
Figure 8.8 Typical beam and column structure

The timber structure will be retained and exposed in both common areas and the hotel rooms with new walls offset to allow for this. The headstocks and beams will be exposed in the common areas and corridors. The structure will be particularly apparent in the lower ground floor and ground floor where there are large, open areas to the restaurants.

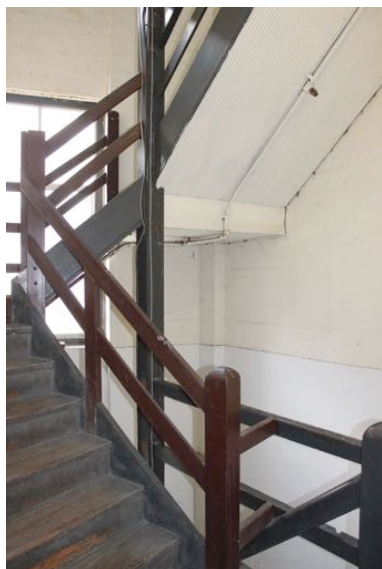
Figure 8.9 Timber stair

The timber stair to the southwest corner of the building is original but will be removed. It is poor condition and would not comply with the BCA if retained for access. The stair has been flagged on the SHI listing sheet as being of some significance and consideration could be given to some interpretation of this by retaining a section or pattern on the walls. However, we consider this is not an element of any quality and support its removal.

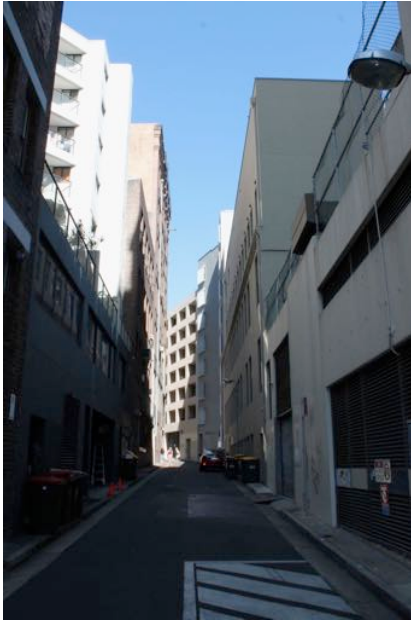
Figure 9.1 Metro Goldwyn Mayer rear elevation to Randle Lane

To the west of the subject site across Randle Lane was the former Metro Goldwyn Mayer, a four storey, Inter War building in a mild Spanish Mission style that was built in 1933. The building was built as offices for the well-known American film studio to the design of Robertson and Marks, architects.

The building has recently been demolished as part of the Metro upgrade of the Chatswood to Sydenham rail line.

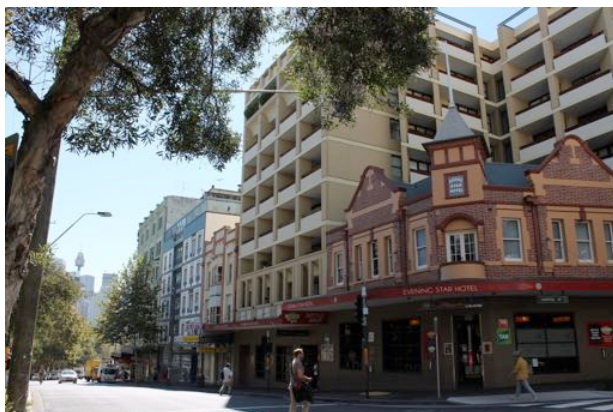
Figure 9.2 The Evening Star Hotel

To the east of the subject site across Randle Street is the Evening Star Hotel, a two storey Edwardian period hotel in the Victorian Free Classical style. The Hotel was built in 1903 but the architect has not been identified.
